Historic Structures Report
Renwick Courthouse, Wallace Library, and Old Jail
City of Fredericksburg, Virginia

Created / Last Revised:
19 April 2016/ 15 June 2016

Prepared by:
Bryan Clark Green, Ph.D.
Commonwealth Architects
101 Shockoe Slip, Third Floor
Richmond, Virginia 23219

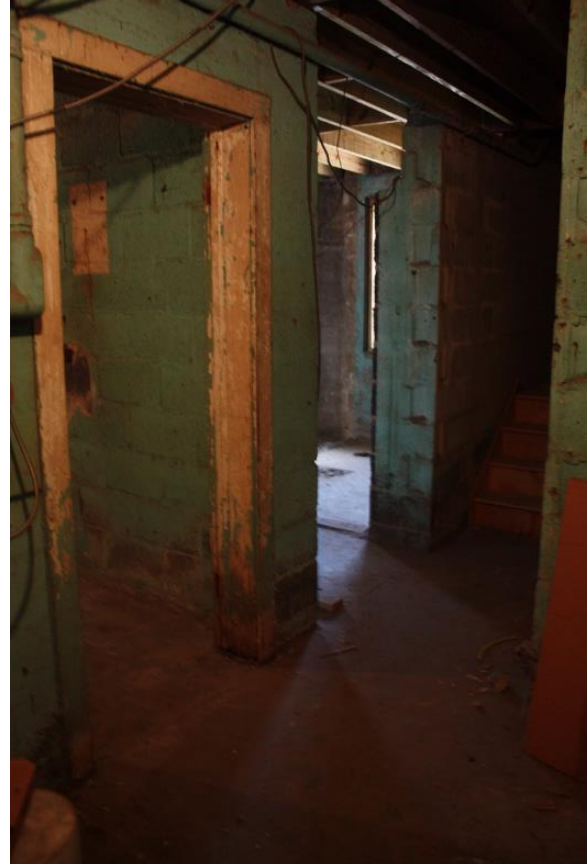
Figure 3.372, Old Jail, Basement, Room 004, general view looking northeast. Note the heavy paint loss at the door frame leading to Room 005.

Doors:
A wood door with painted, flat wood trim leads to the space under the stairs. A former door opening at the west wall is infilled with concrete block and partially covered by nailed-on, horizontal wood slats. A door opening with flat wood trim is located at the north wall and leads to Room 005; there is heavy paint loss at the trim.

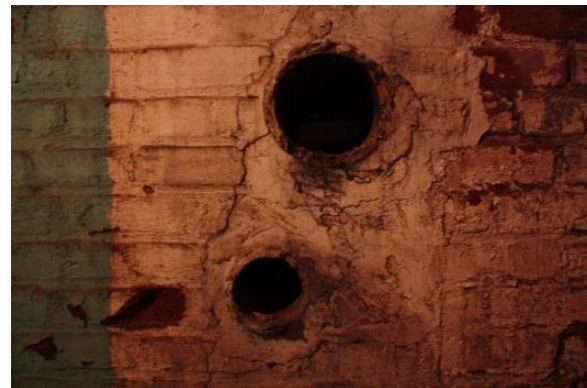
Figure 3.373, Old Jail, Basement, Room 004, detail view of holes at the south wall.

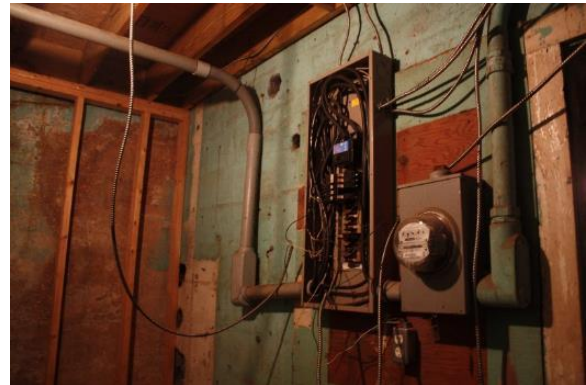
Figure 3.375, Old Jail, Basement, Room 004, view of the electrical panel and exposed wiring at the north wall.

Other:
There is an electrical panel at the north wall. The wires leading to it are exposed.

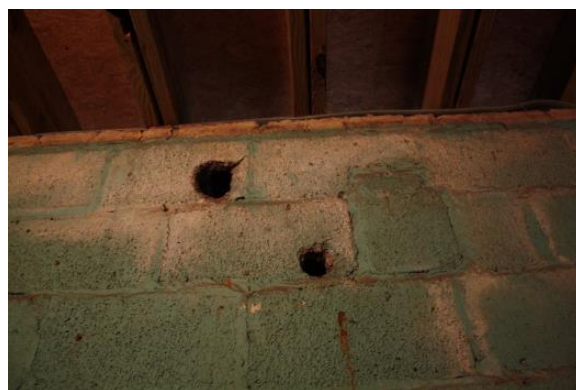
Figure 3.379, Old Jail, Basement, Room 005, detail view of holes at the east wall.

The interior walls (east and south) are of concrete block and the exterior walls (north and west) are of poured-in-place concrete. There are holes at the north and east walls and each wall exhibits large areas of paint loss. A large vertical crack is located under the window at the north wall.

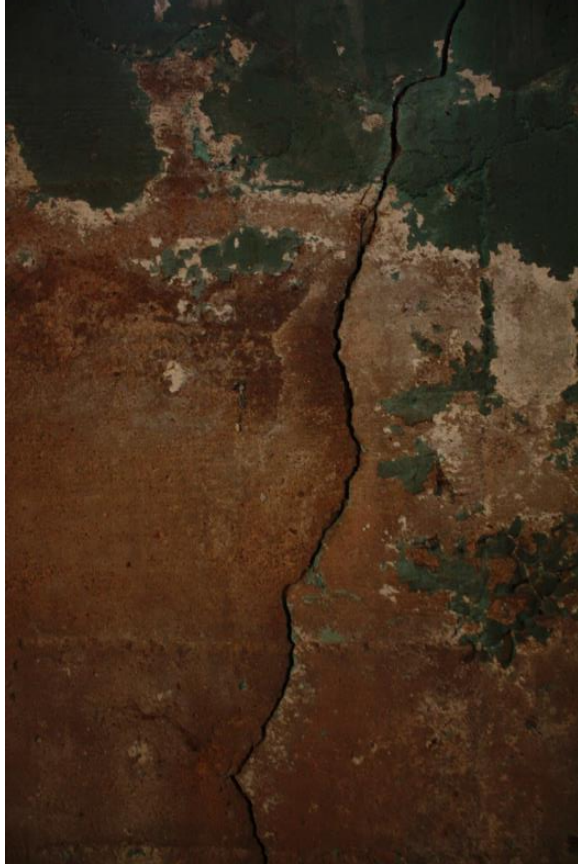
Figure 3.380, Old Jail, Basement, Room 005, detail view of a vertical crack underneath the window at the north wall.

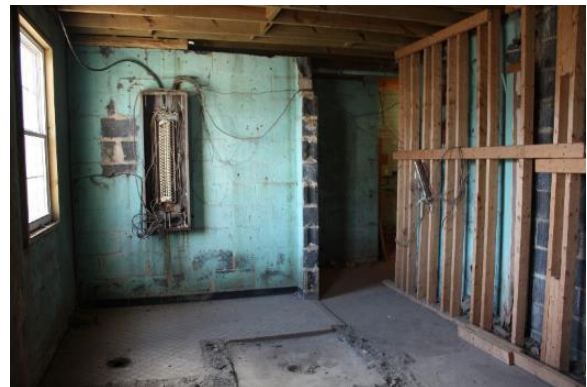
Figure 3.382, Old Jail, Basement, Room 006, general view looking south. Note the electrical panel with exposed wires; moisture staining of the south wall; general paint loss at each wall; and the unfinished wall framing at the west wall.

The interior walls (south and west) are of concrete block and the exterior walls (north and east) are of poured-in-place concrete, with wood framing at the west wall. There is a large area of moisture staining under the

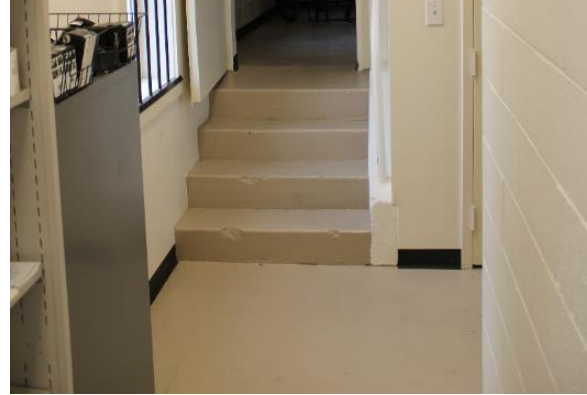
Figure 3.394, Old Jail, First Floor, Room 102, view of the concrete stair between Rooms 101 and 102. Note the small areas of loss at the ends of the treads.

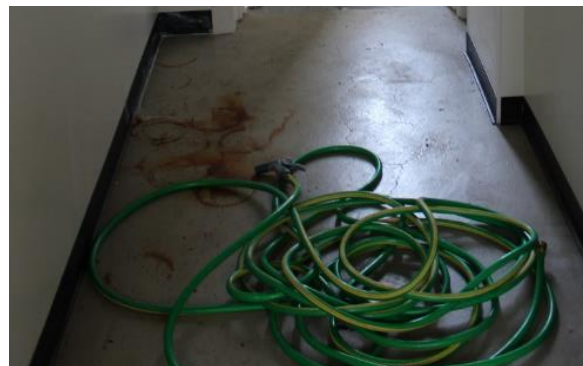
Figure 3.398, Old Jail, First Floor, Room 104, general view looking east. Note the rust stains at the floor.

Figure 3.403, Old Jail, First Floor, Room 104, detail view of the circular rust stains at the floor in the center hall.

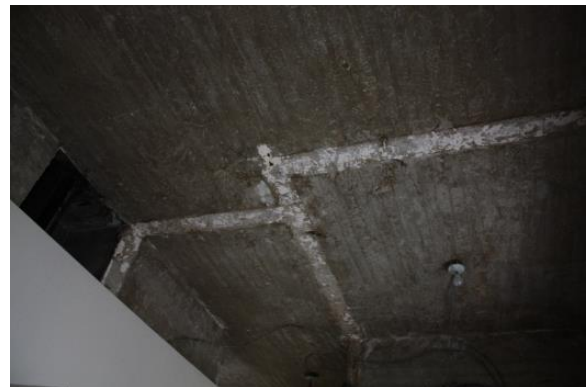
Figure 3.407, Old Jail, First Floor, Room 105, view of the poured-in-place concrete ceiling. Note the linear marks at the ceiling where there were formerly walls.

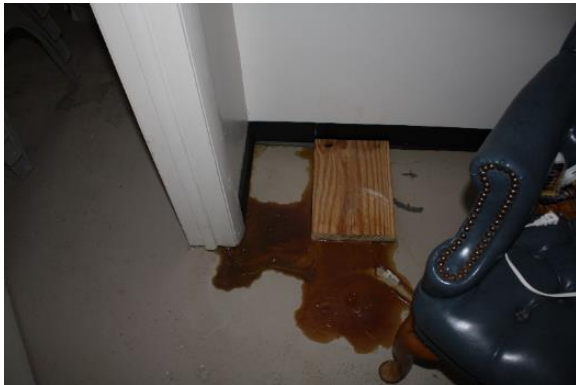
Figure 3.408, Old Jail, First Floor, Room 105, view inside closet at north wall. Note the liquid at the floor.

The closet at the east wall is an unfinished space with concrete walls and floor, containing plumbing that services the sinks and toilets in the adjacent jail cells (Rooms 106 and 107). The closet at the west wall has the same finishes as the main room; there is a puddle of brown liquid at the floor.

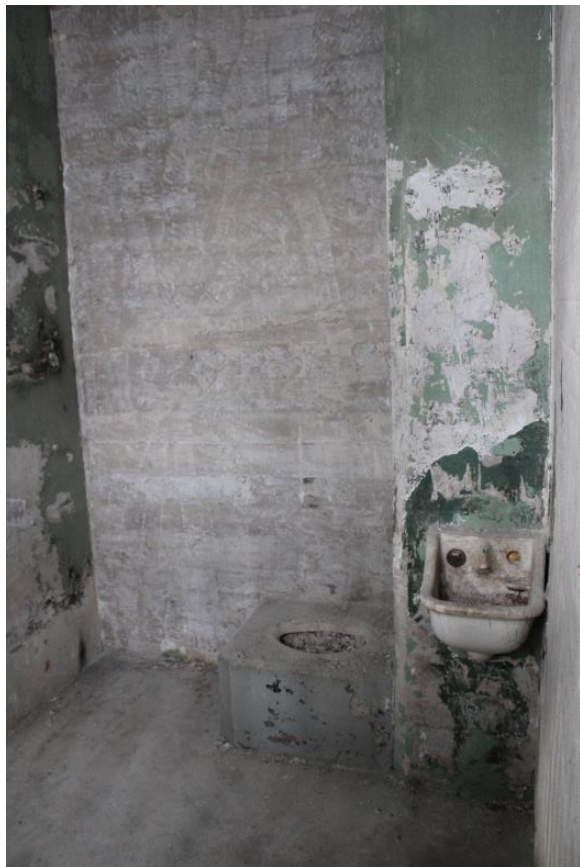
Figure 3.410, Old Jail, First Floor, Room 106, view looking west. Note the heavy paint loss at the walls.

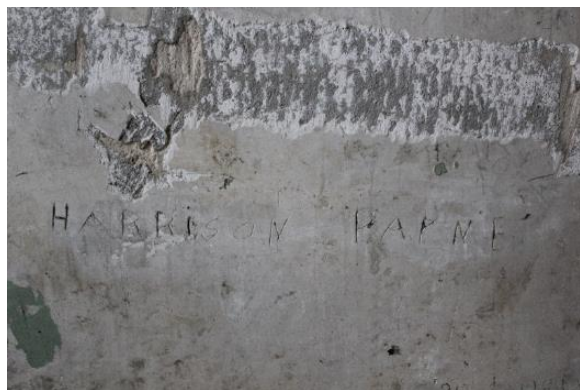
Figure 3.411, Old Jail, First Floor, Room 106, view of graffiti at the wall.

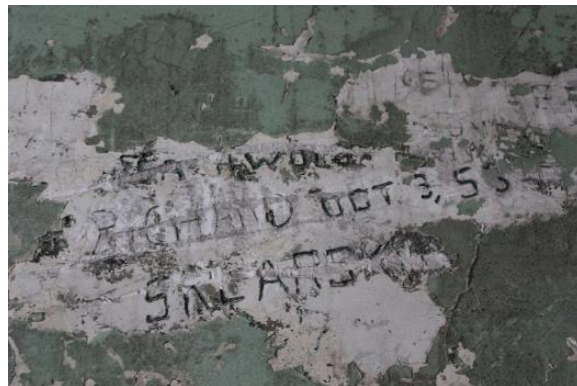
Figure 3.412, Old Jail, First Floor, Room 106, view of graffiti at the wall.

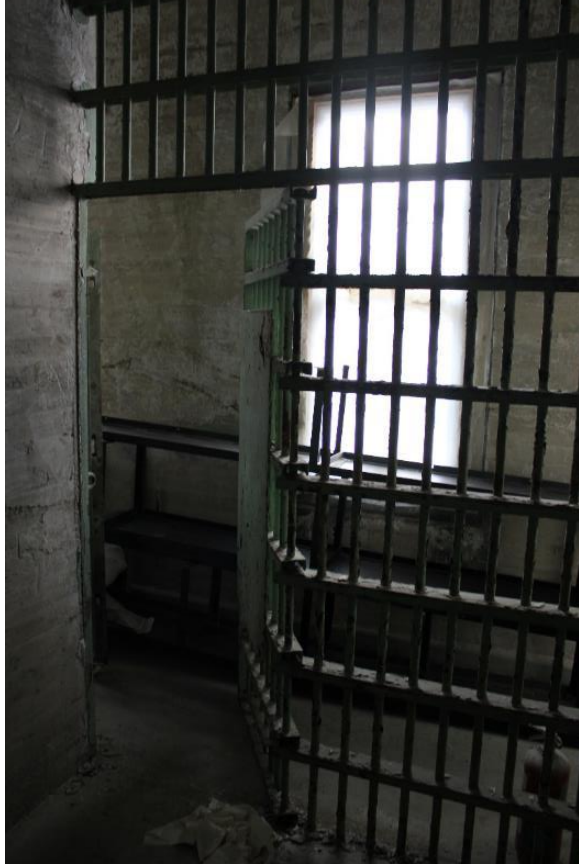
Figure 3.413, Old Jail, First Floor, Room 106, view of bars and door forming east wall of cell.

The room is a jail cell; floor-to-ceiling metal bars form the east wall and have a door at the north end, also of metal bars. The bars are heavily rusted with many areas of paint loss.

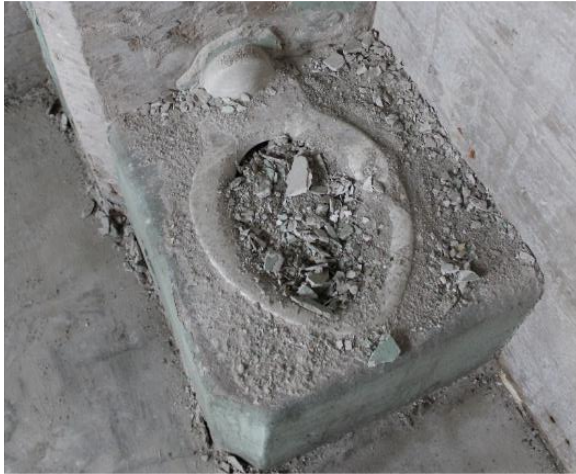
Figure 3.418, Old Jail, First Floor, Room 107, view of toilet filled with debris.

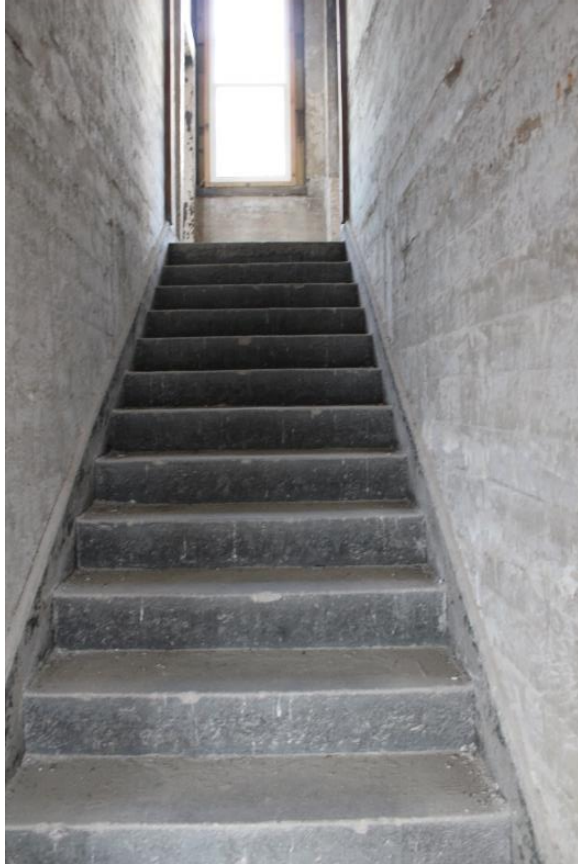
Figure 3.422, Old Jail, First Floor, Room 108, view of stair from first story; note the small areas of loss at the ends of the treads.

An enclosed quarter-turn stair at the north end of the room leads to Room 201 at the second floor. It has a short lower flight and long upper flight. It is of concrete construction, including the stringers, and does not have a handrail. The stairwell has poured-in-place concrete walls and ceiling. There is a crack in one of the walls. At the ends of the stair treads there are small areas of loss.

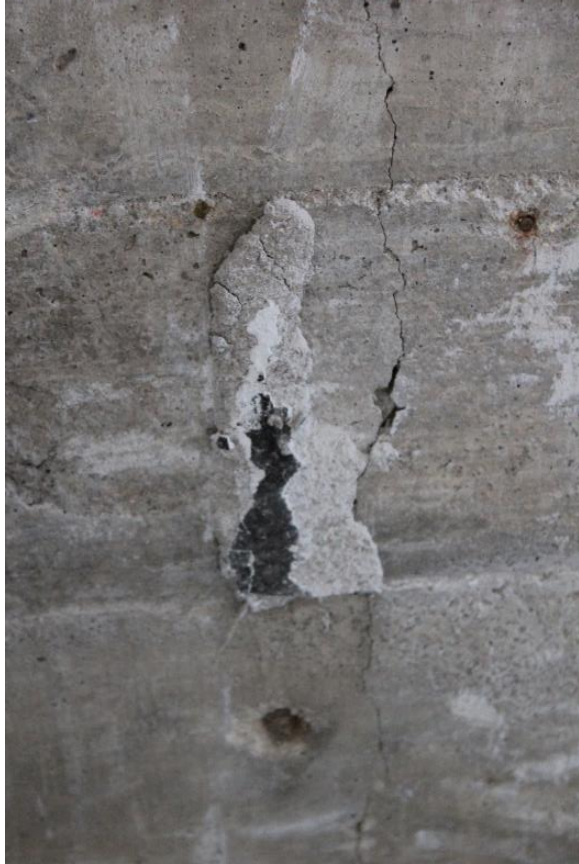
Figure 3.424, Old Jail, First Floor, Room 108, view of a crack in the wall at the stair hall.

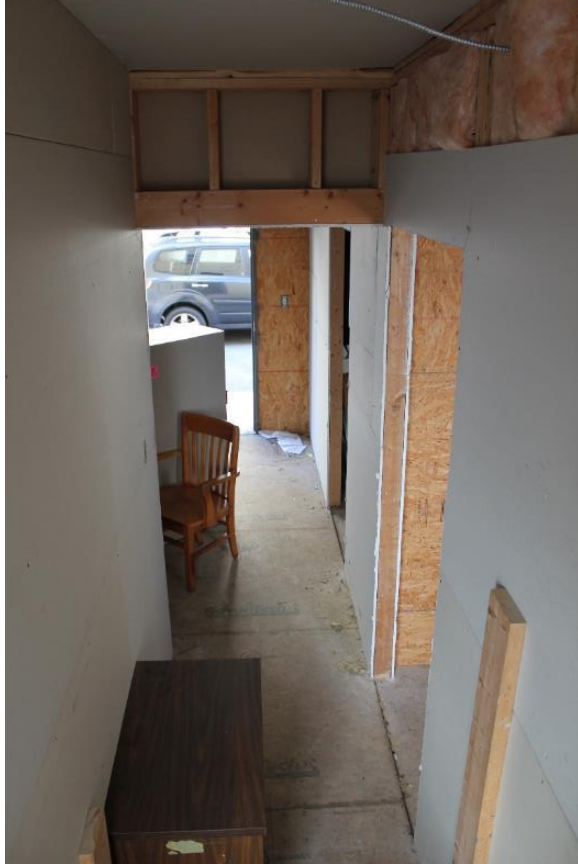
Figure 3.426, Old Jail, First Floor, Room 109, general view looking west from stair hall. Note the exposed insulation along the top of the north wall.

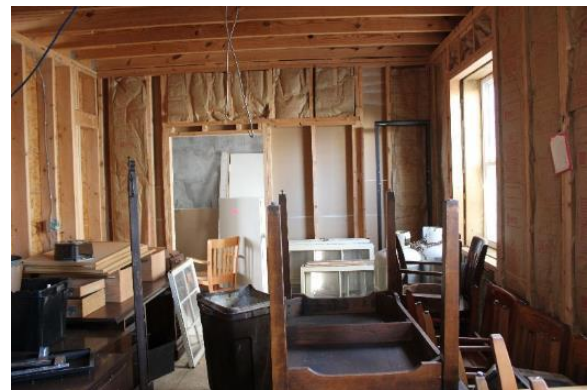
Figure 3.430, Old Jail, First Floor, Room 110, general view looking south. Note the unfinished state of the room and the large quantity of stored furniture and other materials.

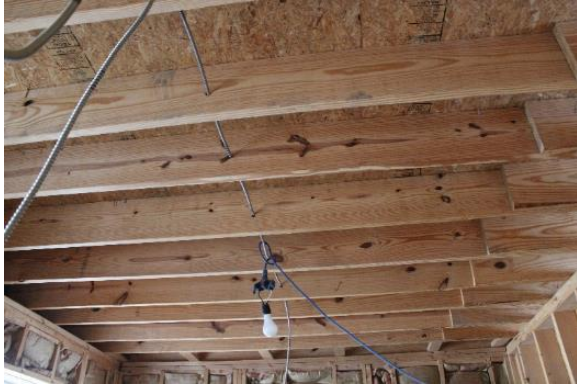
Figure 3.431, Old Jail, First Floor, Room 110, view of exposed wood floor framing at the ceiling.

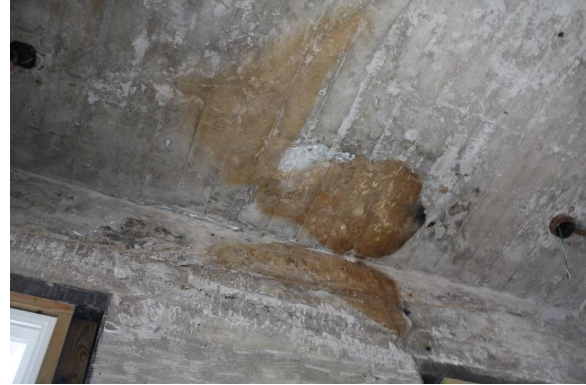
Figure 3.439, Old Jail, Second Floor, Room 201, view of moisture staining at the ceiling.

The ceiling is of concrete with three east-west-oriented concrete beams. There are some rust-colored moisture stains at the ceiling.

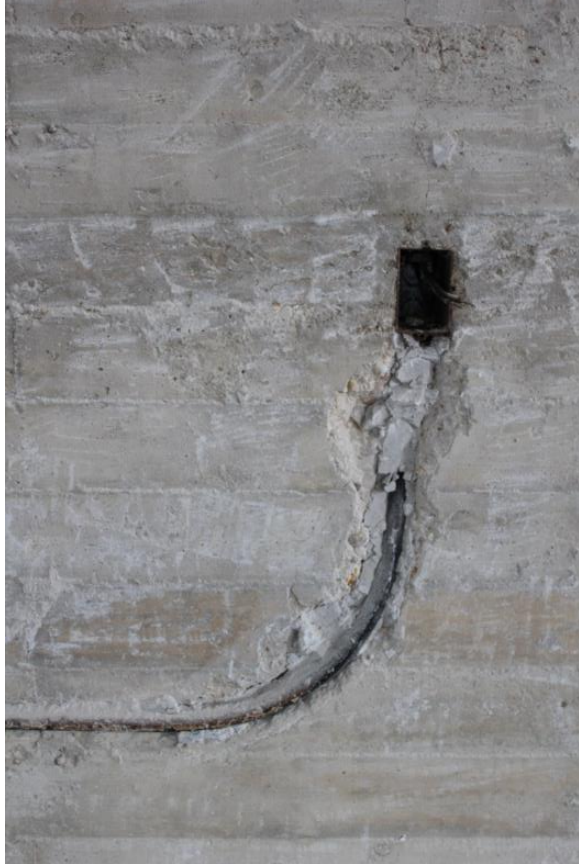
Figure 3.440, Old Jail, Second Floor, Room 201, view of remnants of a former electrical outlet and conduit at the north wall.

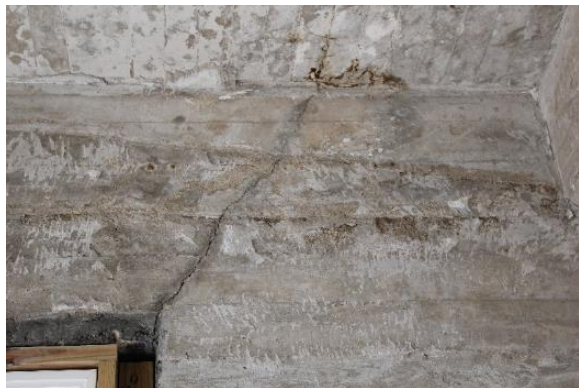
The walls are of concrete and have a painted concrete base. The base has large areas of paint loss. There are diagonal cracks in the wall at the top corners of some of the windows, mostly those in the southeast and southwest corners of the room. At the north wall are remnants of a former electrical outlet and conduit. There are large concrete patches at the wall underneath some of the windows.

Figure 3.441, Old Jail, Second Floor, Room 201, view of a diagonal crack in the wall at the upper corner of the window.

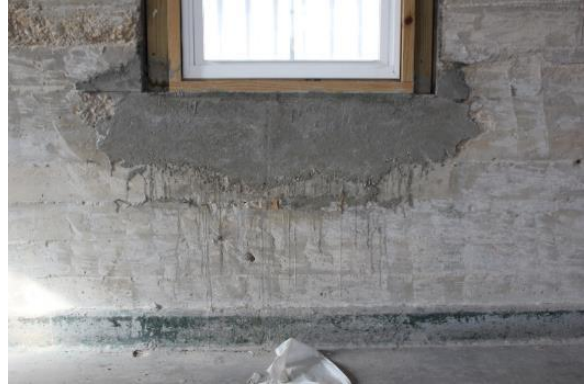
Figure 3.442, Old Jail, Second Floor, Room 201, view of a concrete patch under a window; similar patches are found at other windows.

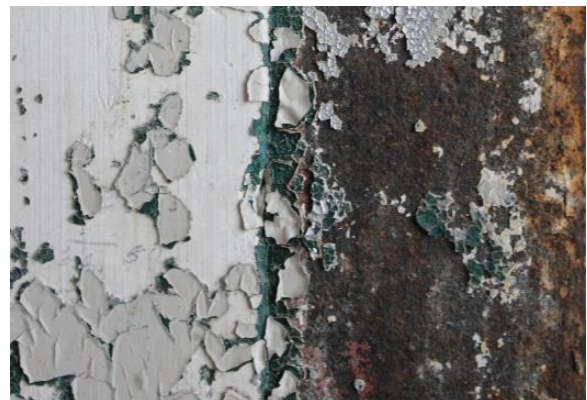
Figure 3.446, Old Jail, Second Floor, Room 201, view of heavy rust and paint loss at the east jail cell door's metal trim, a condition also found at the trim of the west doorway trim.

There is a door opening at the west end of the north wall and a jail cell door of metal bars leading to the shower stall at the east end of the north wall. Both doors have wide, flat, painted metal trim; the trim at both doorways and the metal bars exhibit heavy paint loss and rusting. A rough opening between Rooms 201 and 202 is located at the top of the stairs, with exposed concrete blocks at the top of the opening.

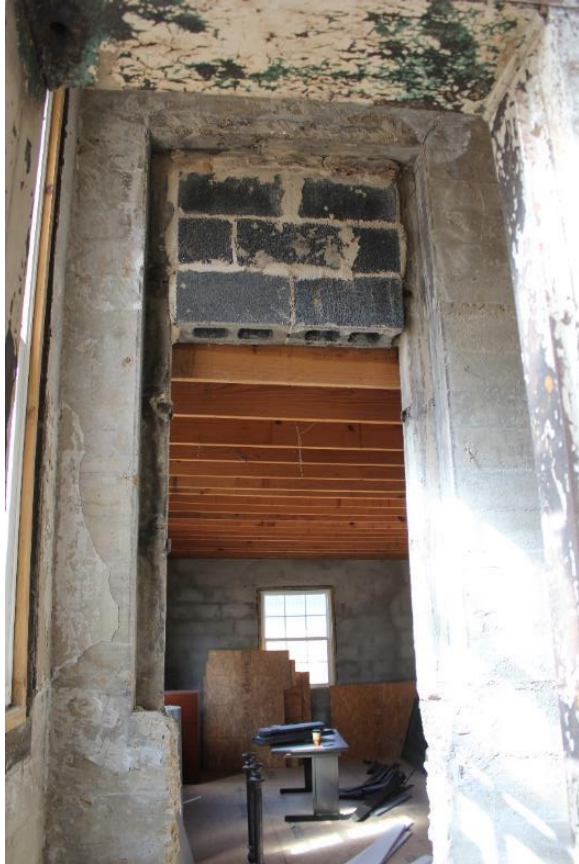
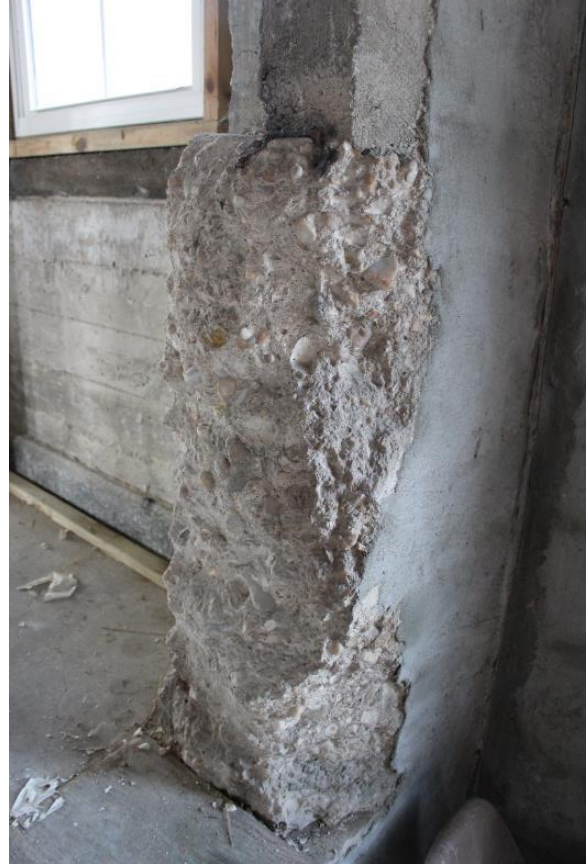
Figure 3.447, Old Jail, Second Floor, Room 201, view of rough-cut opening between Rooms 201 and 202 at the top of the stairs.

Figure 3.448, Old Jail, Second Floor, Room 201, detail view of the rough-cut opening between Rooms 201 and 202.

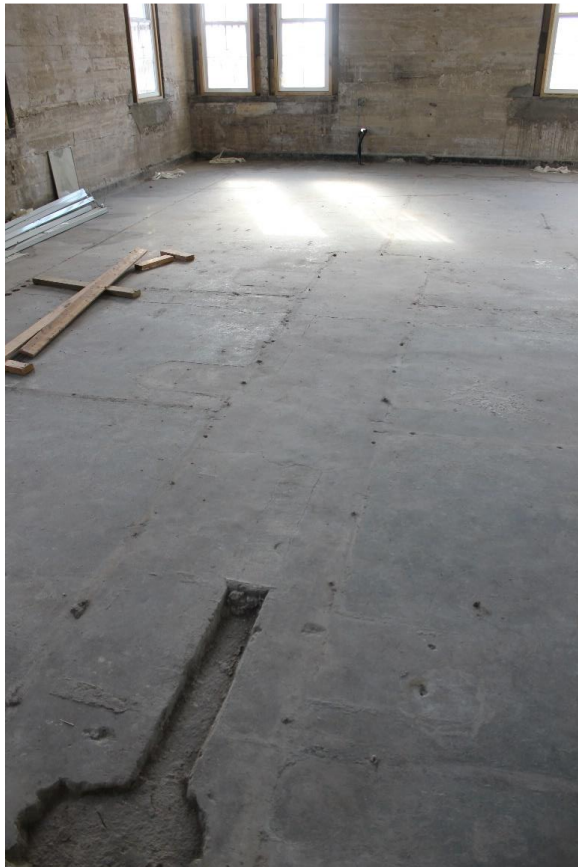
Figure 3.450, Old Jail, Second Floor, Room 201, view of scarring at the floor from former jail cell walls and sanitary line.

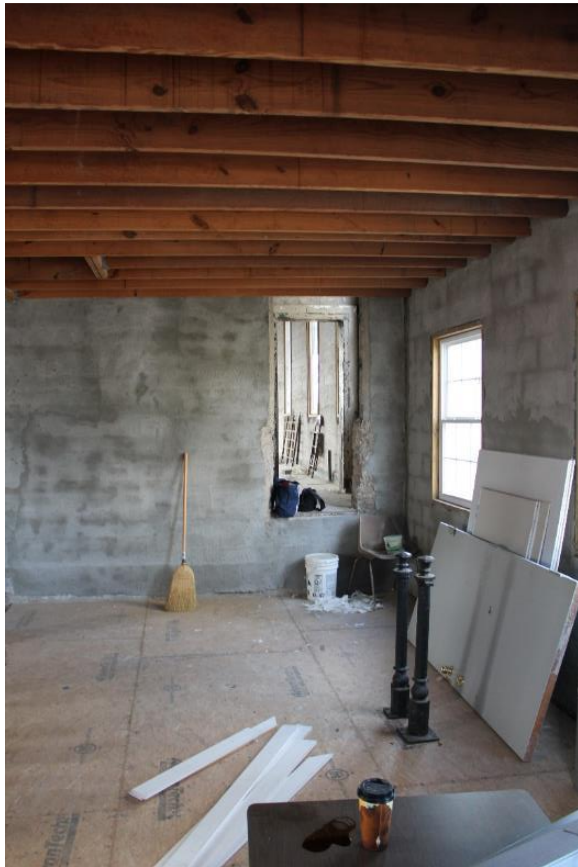
Figure 3.451, Old Jail, Second Floor, Room 202, general view looking south in the west end of the room. Note the unfinished state of the room and that there are no stairs accessing the rough-cut opening to Room 201.

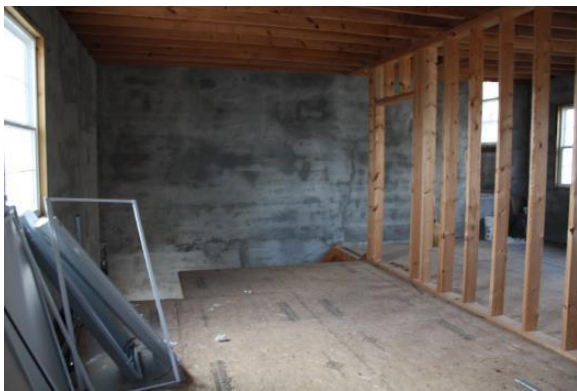
Figure 3.454, Old Jail, Second Floor, Room 202, general view looking south in the east end of the room. Note that the floor is open to the stairwell below and there is no railing, posing a safety hazard. Also note the unfinished wall framing dividing the room.

The floors are of unfinished particle board. At the southeast corner of the room, the floor is open to the stair below and there is no railing, posing a safety hazard.

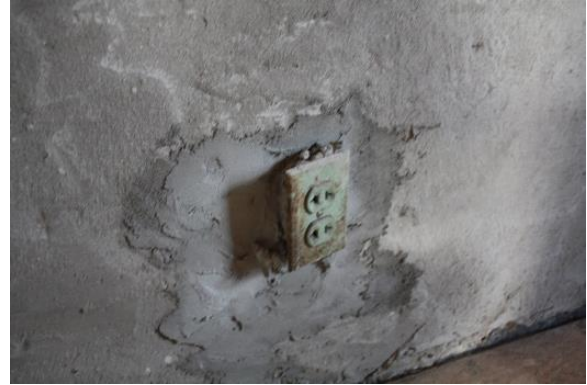
Figure 3.455, Old Jail, Second Floor, Room 202, view of a patch in the wall around an electrical outlet.

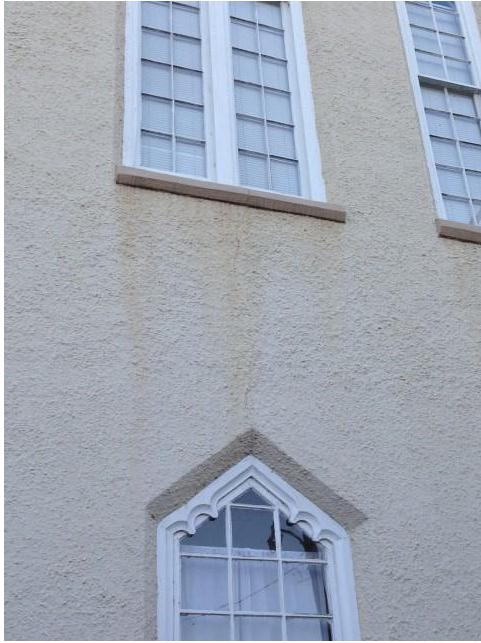
While the exterior load-bearing walls appear to be in a relatively good condition, there are localized cracks in the stucco around windows on the east façade and near the base of the building at the north entrance (Figure 4.07 & 4.08). Localized deterioration of the caps on the buttresses was also observed. While these

conditions are not necessarily indicative of structural distress, cracks in the stucco allow water to infiltrate and become trapped between the brick and the stucco and can cause deterioration of the brick and mortar in the long term.

Figure 4.07: East façade with stucco cracking between windows.

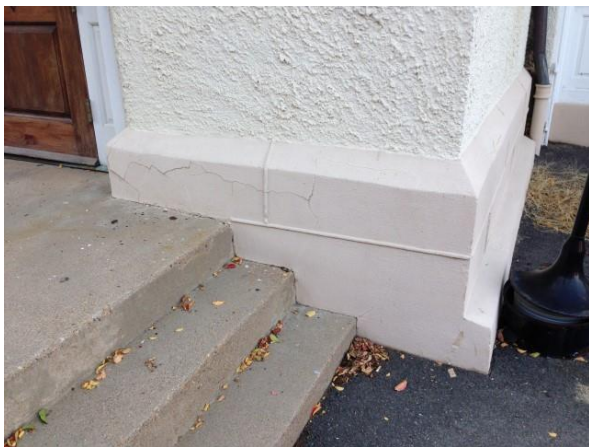
Figure 4.08: North stair to courthouse with crack in stucco near base.

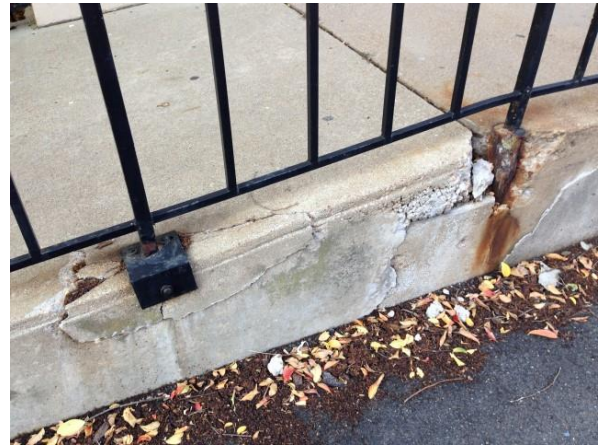
tower entrance, are exhibiting signs of long term wear. Corroding, embedded railing elements have caused the surrounding concrete to crack and spall at the south entryway ramp and the north stairway (Figure 4.09). Cracking is also present at the west stairs.

Figure 4.09: South entryway ramp with concrete spalling due to rusting railings

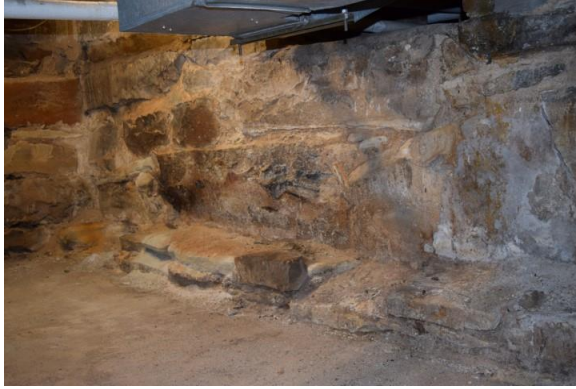
Figure 4.10: Large stone foundation walls under north wing with projecting footings at base

Significant mortar deterioration was observed, and some water infiltration was evident. The original lime based mortar has lost its cohesion and has disintegrated to sand. Along the east side of the crawl space, a large diagonal crack through the mortar joints was observed. The walls have been altered in the course of previous renovations and now have multiple penetrations for mechanical and plumbing elements.

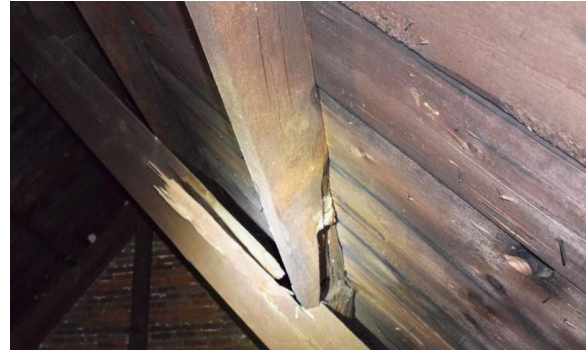
Figure 4.15: Splintered purlin and truss top chord, rumored to be due to cannon ball damage

The roof boards and framing have localized areas in need of repair. In one area, purlins, a truss top chord, and roof boards have been damaged and broken, possibly evidence of what is rumored to be cannon ball damage from the Civil War (Figure 4.15).

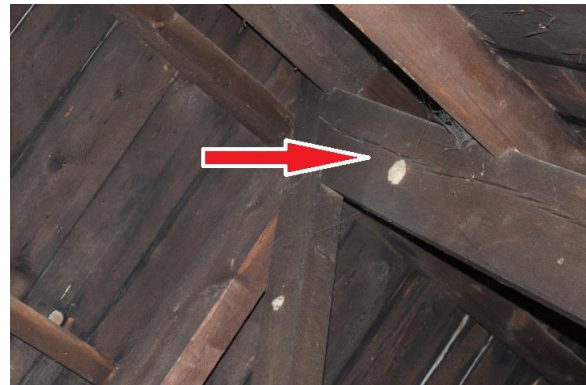
More typically, various truss members are exhibiting shear cracks and crushed bearing ends (Figures 4.16 & 4.17). These overstressed members were observed most frequently in the two trusses with greater distances to the trusses on either side, and therefore higher loading.

Figure 4.16: shear crack in top chord of north wing king post roof trusses

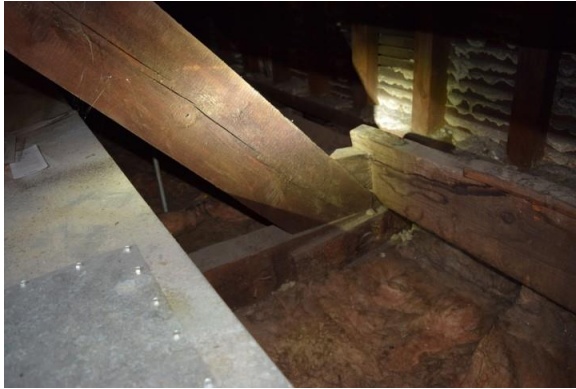
Figure 4.17: Crushing truss bearing end

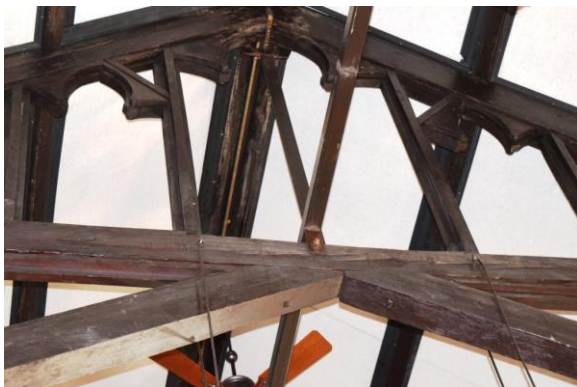
The trusses are exhibiting signs of over-stress and some deterioration, with the trusses in the center of room showing the most evidence of distress. These conditions are described below and locations are summarized in Table 4.02.

- Longitudinal cracking of the horizontal members due to overstress (Figure 4.24).
- Transverse cracking of the multi-ply curved members due to excessive deflections (Figure 4.25).
- Localized cracking emanating from bolted connections, where the connectors push or pull against the wood and create a crack along the force line (Figure 4.26).

Figure 4.24: Longitudinal crack in collar tie

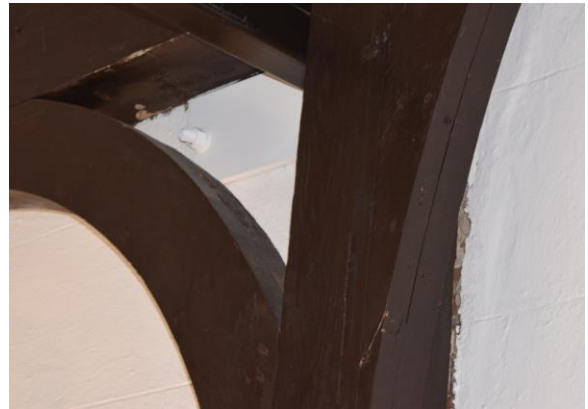
Figure 4.25: Transverse crack in collar brace

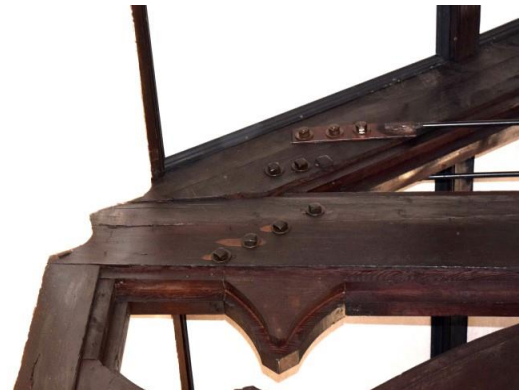
Figure 4.26: Crushing of hammer beam end and localized cracking at tie rod connection to top chord.

Crushing of the wood at one truss bearing end appears to have been caused by a combination of localized water damage and high bearing loads (Figure 4.26).

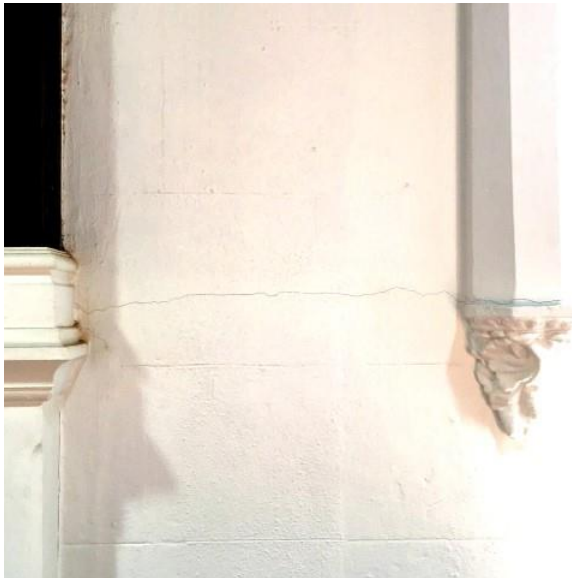
In the court room, the masonry load-bearing walls are coated in a layer of white plaster, scored to look like stone. While the historic plaster is generally in excellent condition, some cracks were observed. These cracks, while rare, can be found between window jambs and truss pilasters (Figure 4.27). Water damage was observed in the acoustic paneling, particularly noticeable around the intersection of the masonry walls and the timber framed roof.

Figure 4.27: Cracking through plaster between window and truss pilasters.

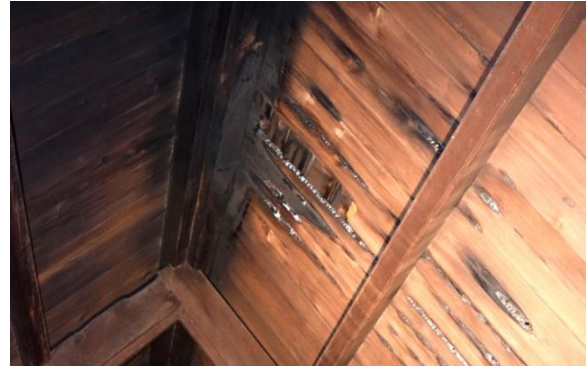
Deterioration observed in the south wing roof framing included fire damage, splintered purlins, through member cracks, water damage, and loss of decorative elements. Evidence of the fire damage consists primarily of charring on the roof sheathing and two ridge purlins (Figure 4.35). No severe structural damage due to the fire was observed on the truss members or the remainder of the purlins.

Figure 4.35: Charred roof sheathing and ridge purlins at east end of south wing

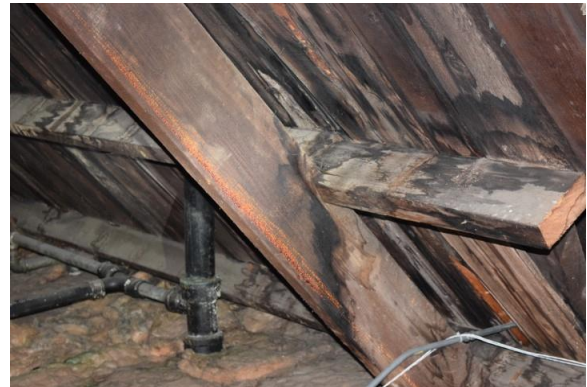
Figure 4.36: Water staining around opening of stairway opening

The visual investigation was performed during a rain storm and no active leakage was observed. However, signs of previous water damage were evident. Water staining on roof sheathing, purlins and truss bearing ends was noticeable in localized areas around the openings to the stair tower roof (Figure 4.36). Between the third and fourth trusses from the West, the third purlin from the bottom is broken and has detached from the roof sheathing (Figure 4.37).

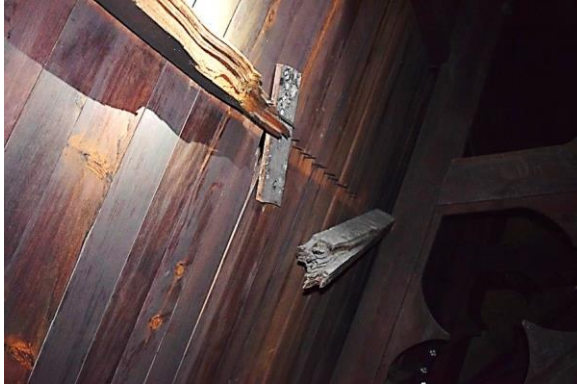
Figure 4.37: Broken purlin at center bay of trusses

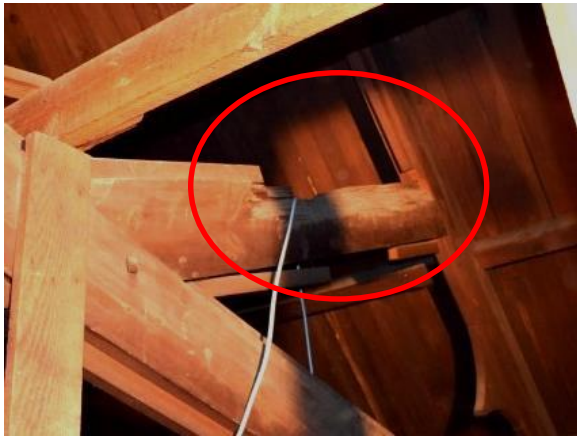
Figure 4.38: Deteriorated scissor truss brace in south wing

Damage was observed in several scissor beams in multiple trusses in the south wing roof framing. Figure 4.38 depicts a scissor brace reduced to nearly half its original section near its upper end. In other locations, the deterioration is less extreme. Cracking was noticed in localized truss members, with significant cracking observed in the bottom chords of the trusses.

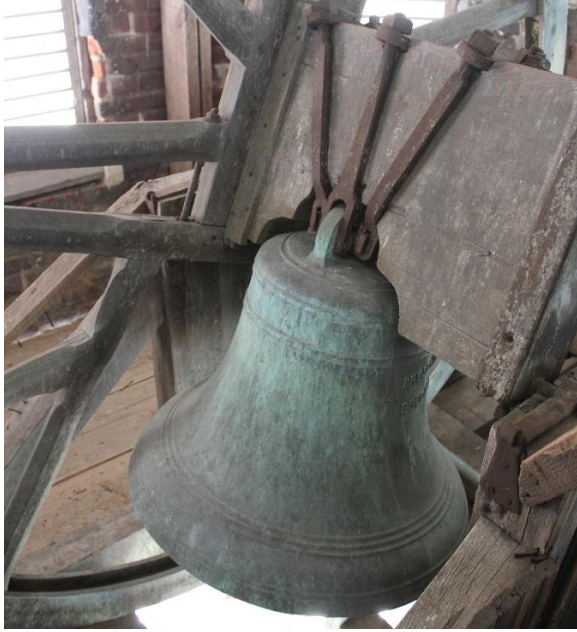
The intermediate floor levels are framed with wood joists. The masonry walls are braced by the floor framing at each level. Additional heavy timber framing supports the large 1828 Revere Company Bell at the 3rd floor (Figure 4.41).

Figure 4.41: 1828 Revere Company Bell

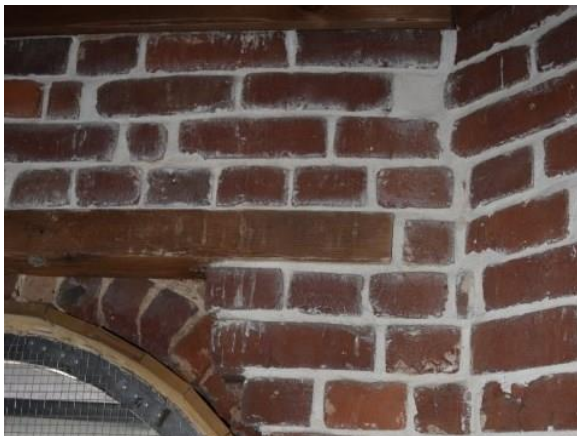
The bell tower was renovated in 2002. Per the renovation drawings, the scope of work included localized repointing of brick (Figure 4.42), epoxy consolidation of wood lintels where needed, partial replacement of wood floor deck, repairing and recoating of the stucco exterior finish, and window and louver repairs.

Figure 4.42: Repointing efforts at top of masonry tower

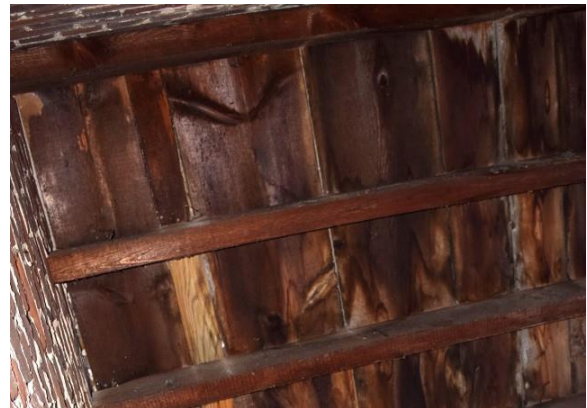
Water staining was evident at joist bearing ends at the second floor framing level (Figure 4.43). Sufficient access was not available to probe the joist ends and determine their soundness, but it is possible that the material could be compromised.

Figure 4.43: Wood bearing ends with water damage at 2nd floor framing level

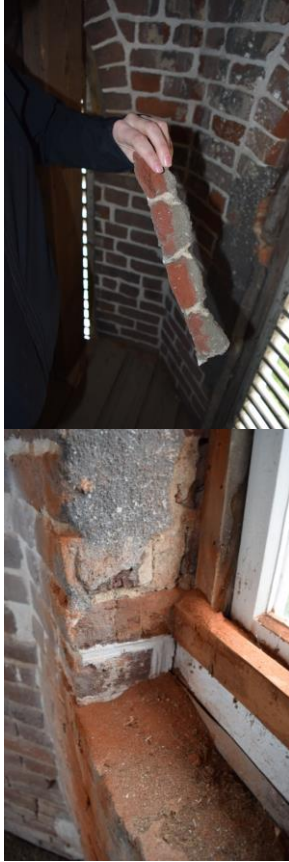
At window and louver openings, open joints were observed in the masonry below the openings. In addition, the brick at window jambs had previously been parged using a cementitious material. The brick behind the parging is severely deteriorated and the parging, along with portions of brick, is separating from the sound masonry (Figure 4.44). These masonry conditions are likely due to water infiltration.

Figure 4.44: Deteriorated brick in and delaminating parging at Bell Tower window jambs

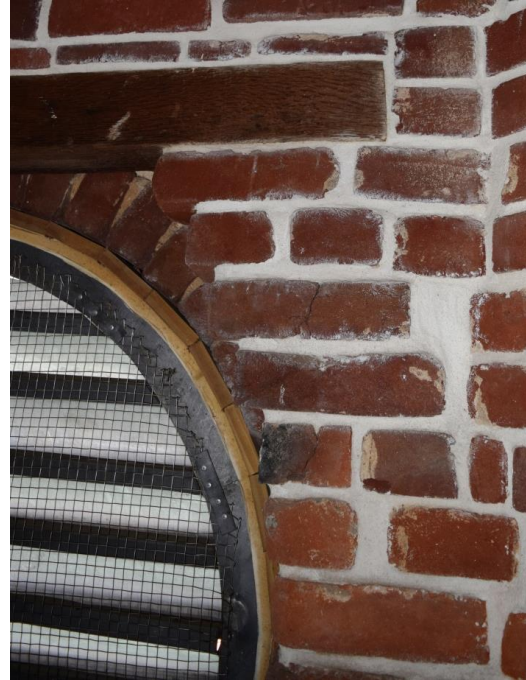
Figure 4.45: Cracking in corbelled brick jamb below wood lintel bearing

At the circular, louvered windows, the exterior wythe of brick contains a brick arch above the opening. The interior wythe of brick is supported on a wood lintel. This lintel bears on corbelled brick below which approximately follows the contours of the window. The brick below the wood lintel bearing is cracked due to excessive stress in the corbel due to the lintel reaction (Figure 4.45).

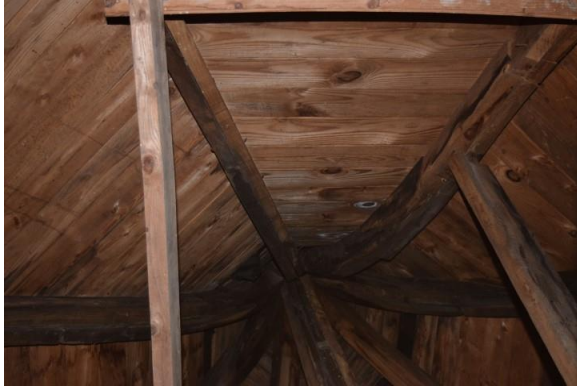
No access to the steeple of the tower was available, but photographs taken through the roof hatch indicate that the cupola is framed with eight rafters meeting at the peak supported on a central post. While the sheathing looks to be of recent construction, the rafters and other wood framing show signs of previous water staining (Figure 4.46). No signs of structural distress such as excessive deflections or cracked members were observed.

Figure 4.46: Cupola framing with water deterioration

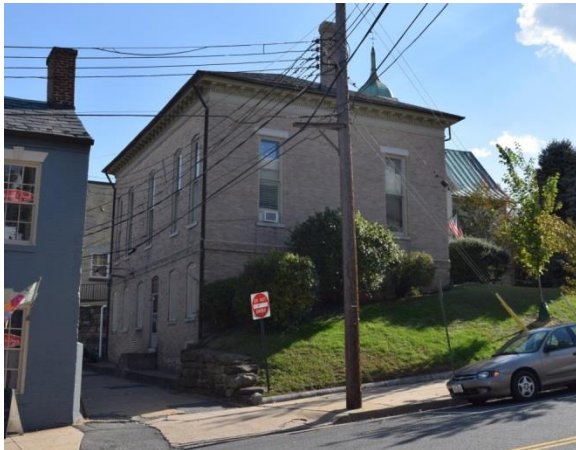
Figure 4.47: View of North and East Facades of the Wallace Library showing site grading

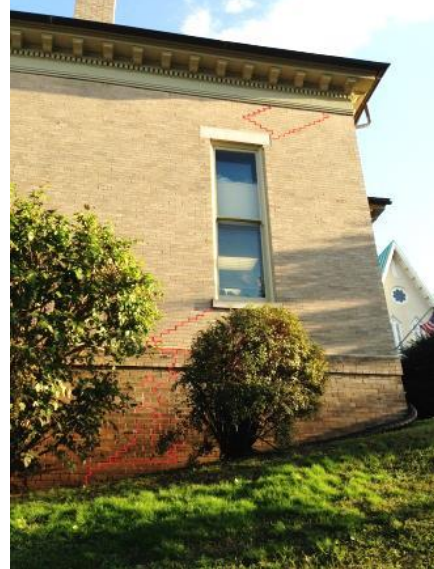
Figure 4.48: Diagonal cracking in North Façade

The north facade of the Wallace library is exhibiting significant diagonal cracking (Figure 4.71). The cracks are evident at the upper northwest corner of the wall near the corner of the window opening, continuing at the lower east corner of the window (Figure 4.72), and meandering down to the foundation level. The vertical joints appear to have wider cracks than the horizontal joints along the cracks.

It is likely that the cracking was caused by the underpinning efforts in the 1970's. Relative vertical movement can occur as a direct result of the underpinning. In addition, the west wall, which experiences lateral pressures from the adjacent soil, originally had soil at the interior helping to resist these pressures. When the wall was underpinned and the interior space excavated, the load path for these lateral loads was changed and the perpendicular walls likely began to experience higher in-plane shear loads to help resist the soil pressures. The combination of these two phenomena likely caused the distress in the north wall.

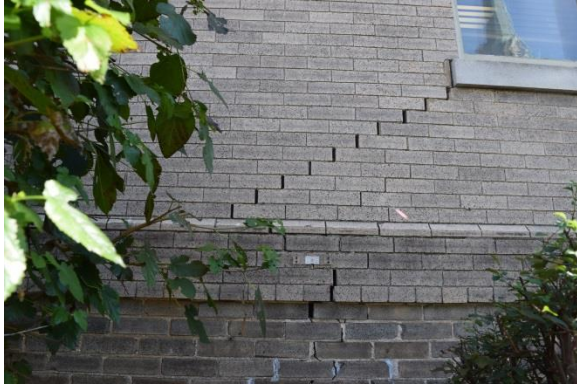
Figure 4.49: Diagonal cracking in North Façade

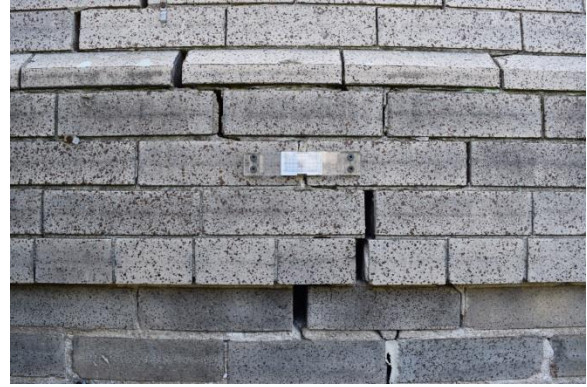
Two crack gauges were installed previously and have been abandoned in place (Figure 4.73). This monitoring was likely implemented to monitor if the movement causing the cracking was active. No data from this monitoring effort was available at the time of this study. It is unclear whether the movement is on-going.

Figure 4.50: Abandoned crack monitoring

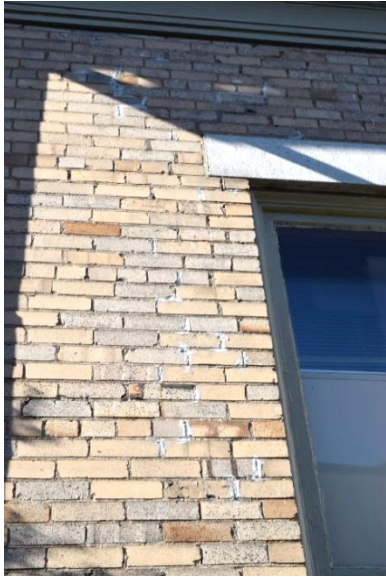
Previous repointing efforts can be observed along the length of the crack as well as at other isolated locations around the building, such as the south side of the library. These earlier repointing efforts appear to have been done with materials that do not match the original mortar in color or composition (Figure 4.74).

Figure 4.51: Incompatible repointing materials at south façade

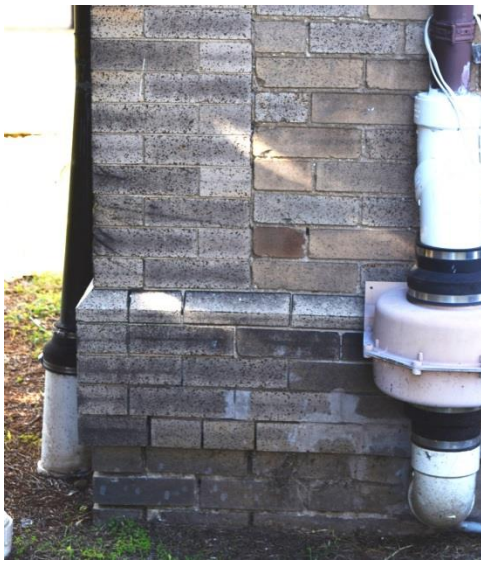
Loss of mortar was also observed in several locations. In the southwest corner of the building, mortar loss is evident near the base of the wall (Figure 4.75). At this location, downspouts appear to be fairly new, and it is possible that they replaced failing or missing ones. Water streaming down the façade at this location could have caused the observed mortar loss.

Figure 4.52: Open mortar joints at southwest corner

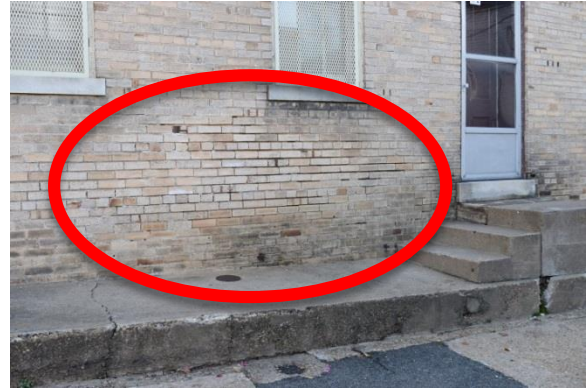
At the east (rear) facade, the brick masonry shows signs of moisture near its base (Figure 4.76). Moisture appears to be present below the interior concrete slab on grade and is finding its way out of the building through the exterior wall. The lime has leached out of the mortar, leaving mostly sand (Figure 4.77). Many open joints are visible as well.

Figure 4.53: East façade with water infiltration

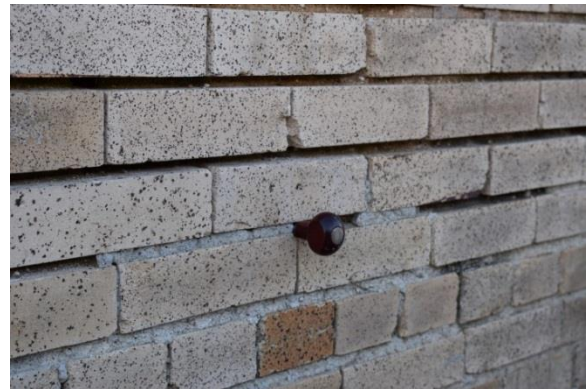
Figure 4.54: Horizontal open mortar joints at east facade of Wallace Library
